Langdon Walkability Assessment 2022

Final Report

Prepared for:
Cavalier County Health District
Langdon, ND

Prepared by:
Kshitij Sharma
Advanced Traffic Analysis Center
Upper Great Plains Transportation Institute
North Dakota State University
Fargo, North Dakota

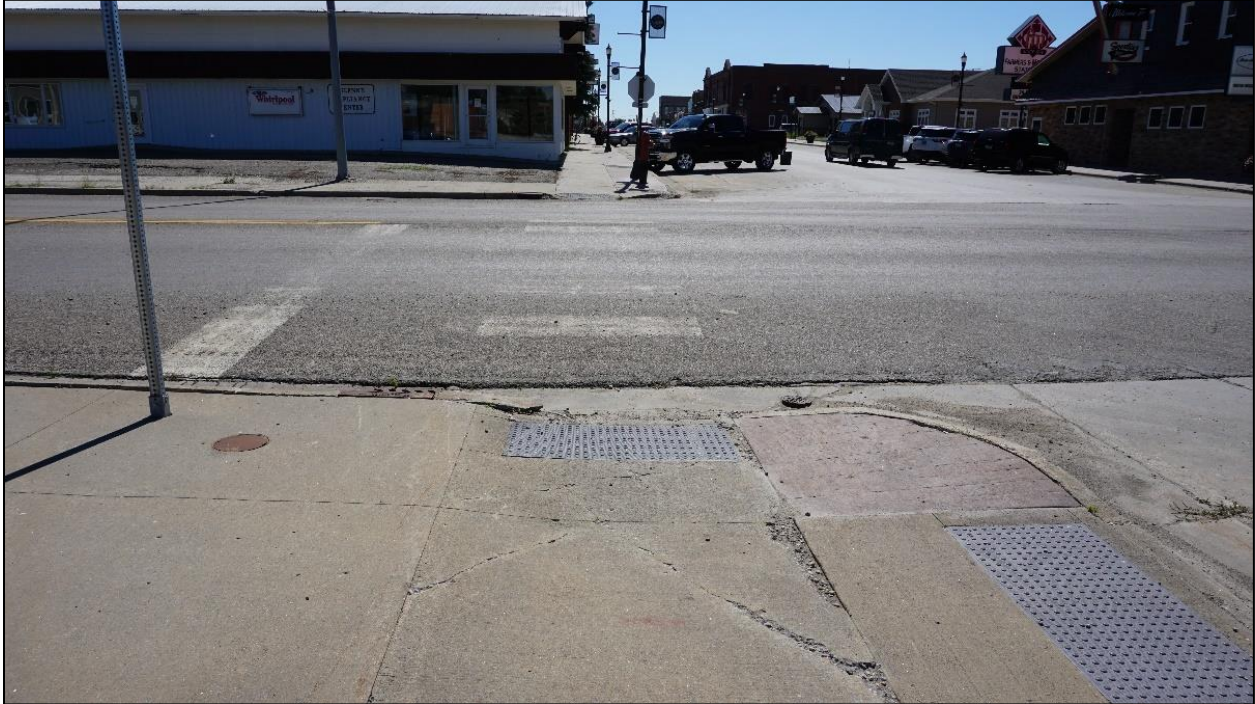
At several locations, as seen in Figure 4, the pedestrian related infrastructure was found to be in a general state of disrepair. Cracked concrete, exposed aggregates, and worn out crosswalk/pavement markings

were observed.

Figure 4. Ramps, sidewalk and crosswalk at Third Street across ND Highway 5

Sections of the sidewalks that are in poor condition should be rebuilt to current standards. New facilities should be installed in locations where missing. In doing so, special attention needs to be paid to state highways. Although outside of town, these highways provide high-speed connectivity over long distances but within built-up albeit rural areas, the same highways need to accommodate access to businesses and other functions for all users including non-motorized users.

- Repair of ramps and displaced sidewalks
- Pavement/crosswalk marking updates/maintenance
- Sign post relocation
- Ensuring clear demarcation of various zones within the right-of-way

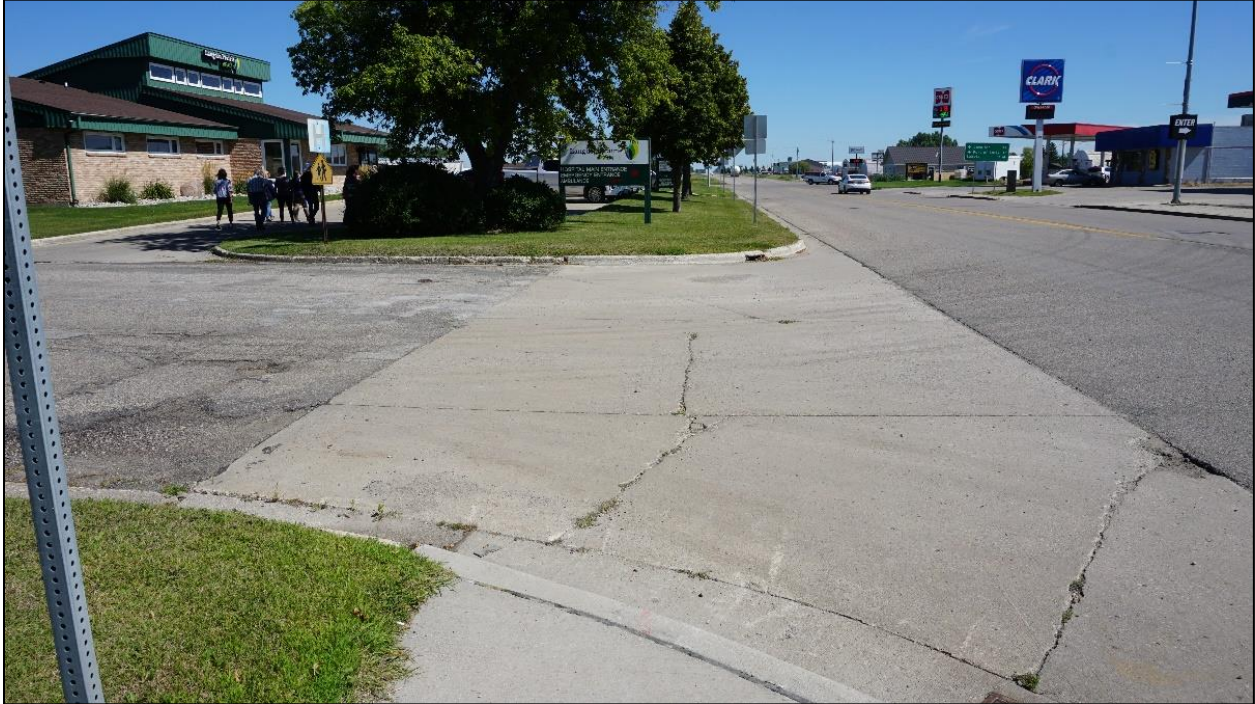
At several locations, as seen in Figure 5, the sidewalks/crosswalks were never installed. The participants are seen walking through parking lots instead.

Figure 5. Missing ramps, crosswalk and sidewalk along ND Highway 5 and participants walking through parking lot

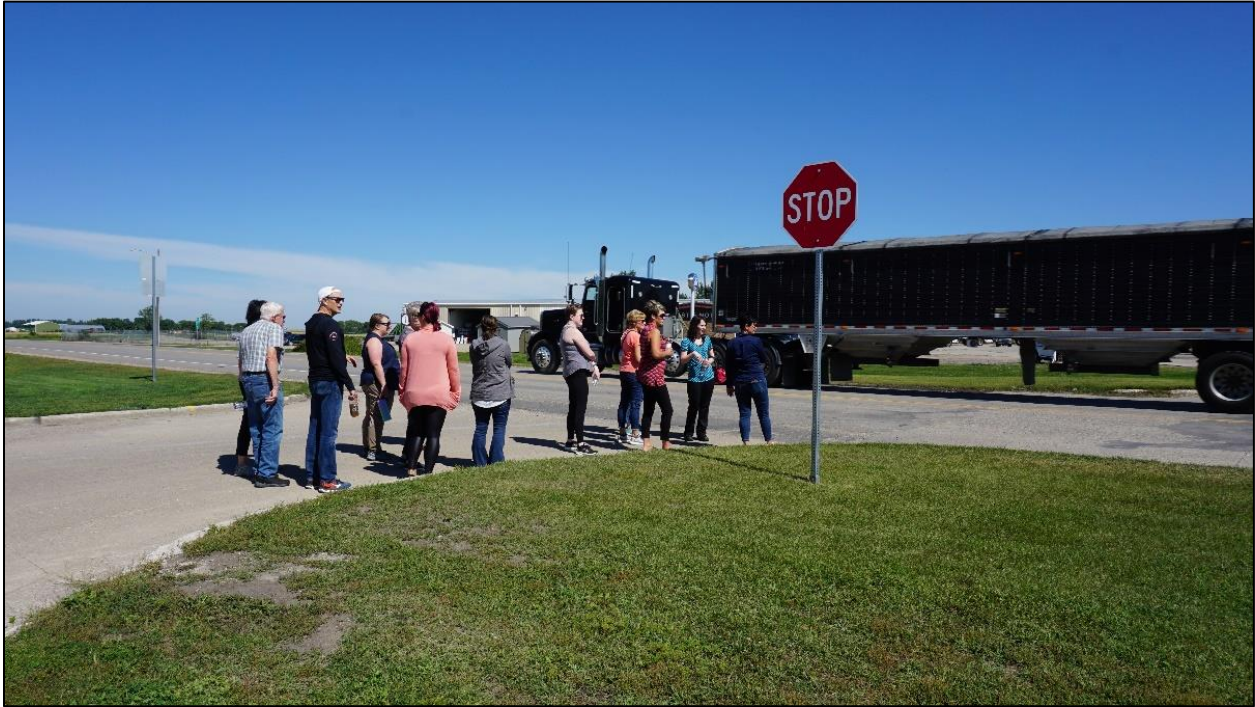
Participants are seen crossing ND Highway 1 at a driveway across from Ninth Avenue East (frontage road) instead of at ND Highway 5 because of a lack of sidewalks/crosswalks, as seen in Figure 6.

Figure 6. Pedestrians crossing ND Highway 1 at Ninth Avenue East

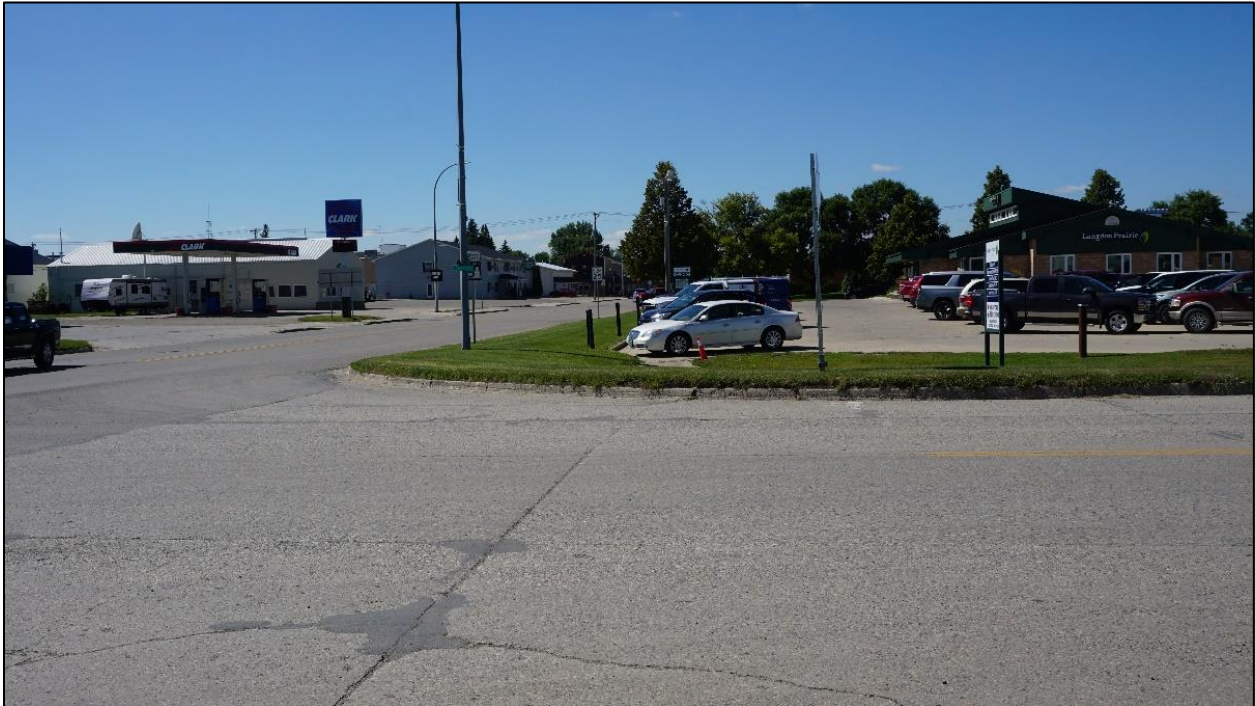
There is no sidewalk along ND Highway 5 on the north side of the street as it passes through Langdon, as seen in Figure 7.

Figure 7. A view of the northwest quadrant and the southbound leg of the intersection of ND Highway 1 and ND Highway

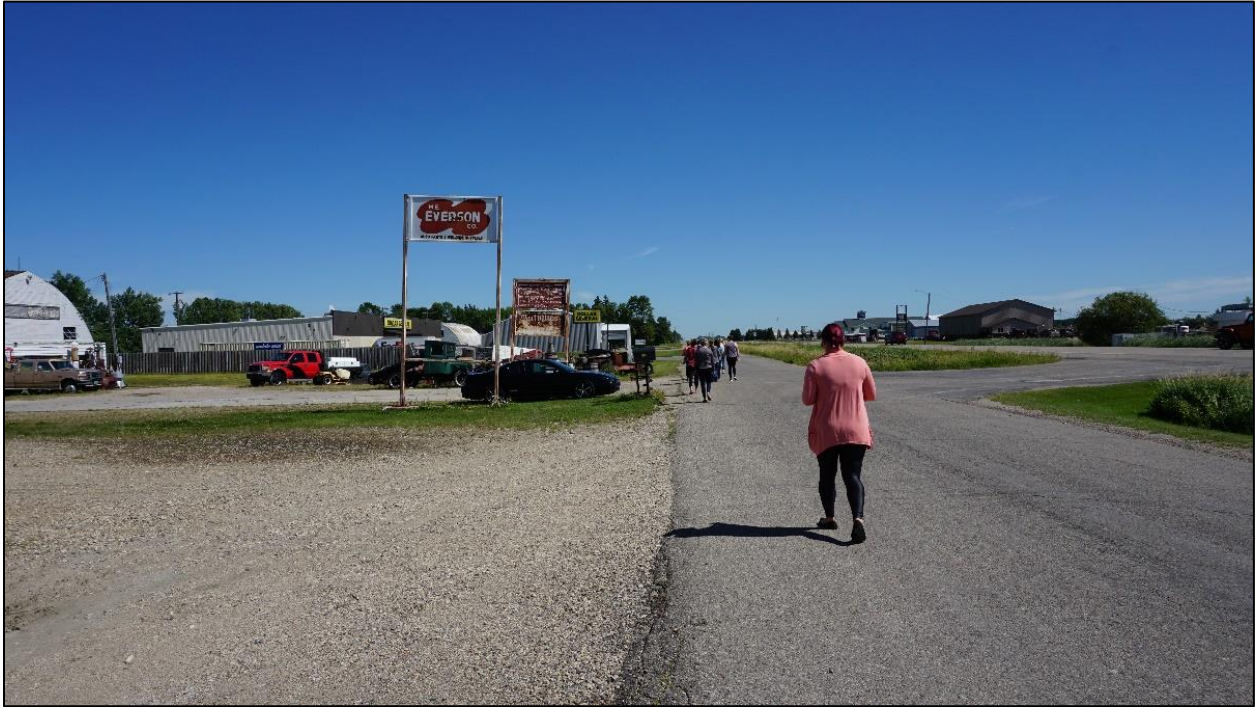
The participants continued the assessment along the frontage road, walking in travel lanes opposing the traffic because of the lack of sidewalk facilities along Ninth Avenue East, as seen in Figure 8.

Figure 8. Participants walking on Ninth Avenue East

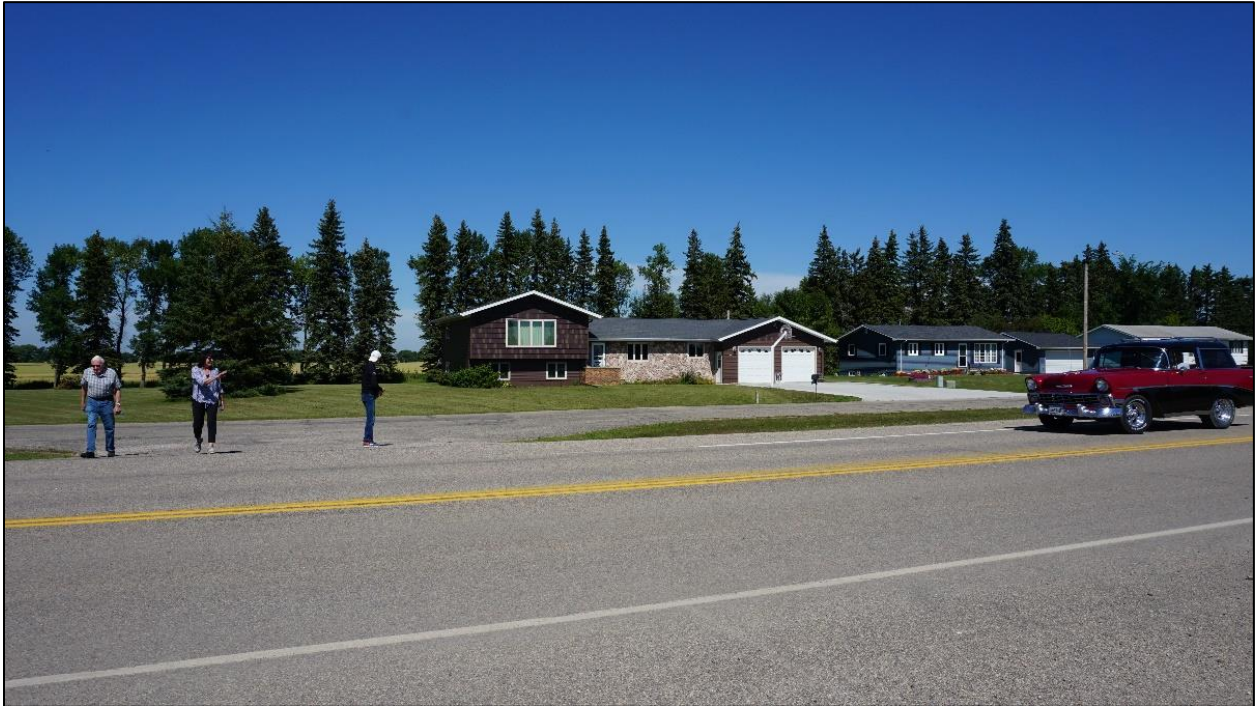
Throughout the assessment, drivers were observed to be courteous toward pedestrians, as seen in Figure 9.

Figure 9. Courteous behavior of drivers in the area

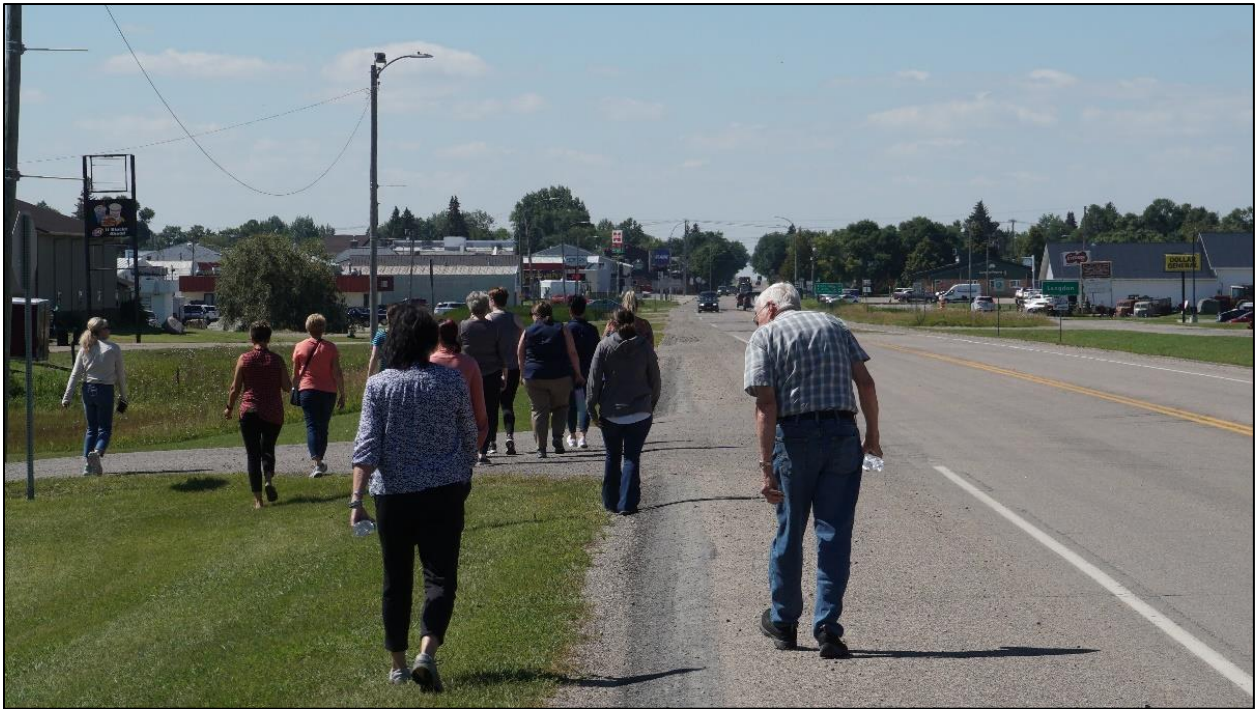
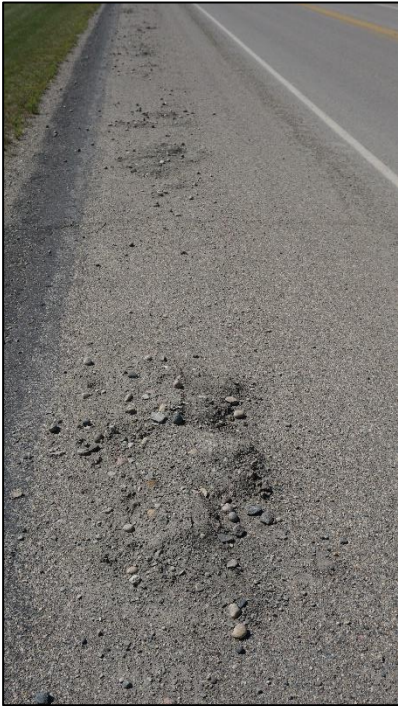
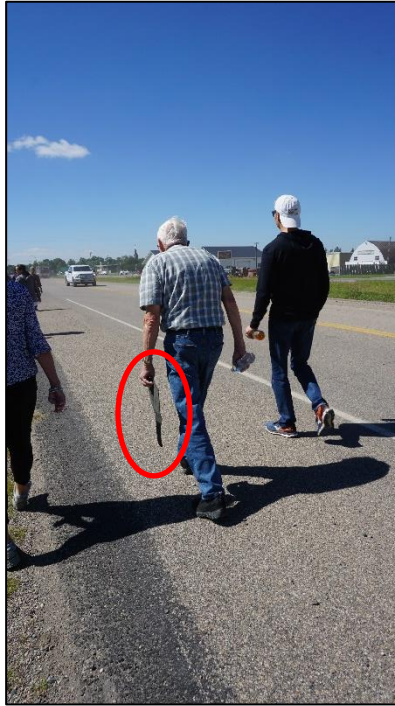
A lot of debris, mud and road hazards were observed especially along ND Highway 5 during the assessment as participants continued the walk facing traffic along the south side of the road as seen in figures 10 and 11.

Figure 10. Participants continuing assessment along south side of ND Highway 5

Most of the debris was observed on the shoulder where a pedestrian/bicyclist may be using the roadway.

Figure 11. Debris and mud along the south side shoulder of ND Highway 5

Figure 12. Participants helping in picking up metal debris from the shoulder

Participants, at times, were observed picking up debris from the roadway. As seen in Figure 12, the debris picked up included metal that could be dangerous for all types of road users. As seen in Figure 13, a puddle of water was observed at the southeast quadrant of the intersection of ND Highway 1 and ND Highway 5. Participants reported that no rain had been received.

A review of current maintenance practices should be completed to see if additional litter removal needs to be scheduled for state highways through the City of Langdon. Road users should be highly discouraged from tracking mud and debris onto the paved lanes and shoulder, thereby reducing road hazards.

Concerned citizens from the area should consider participating in the North Dakota Department of Transportation's Adopt-A-Highway program thereby reducing litter/road hazards and saving taxpayers' dollars.

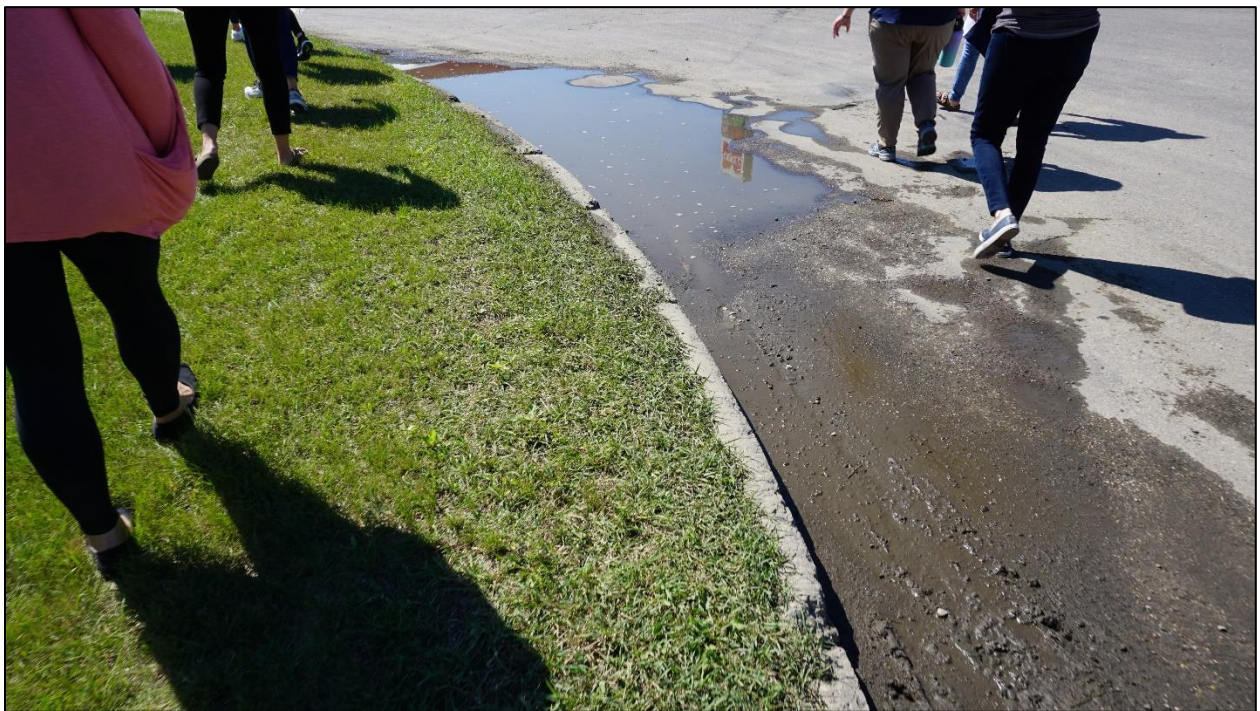
Figure 13. Puddled water at the southeast quadrant of the intersection of ND Highway 1 & ND Highway 5

Slope and drainage at the intersection of ND Highway 1 and ND Highway 5 should be reviewed to ensure that puddling of water as observed is not a frequent issue. Apart from being a nuisance, such issues may pose safety concerns especially during the winter, when it may lead to icy conditions.

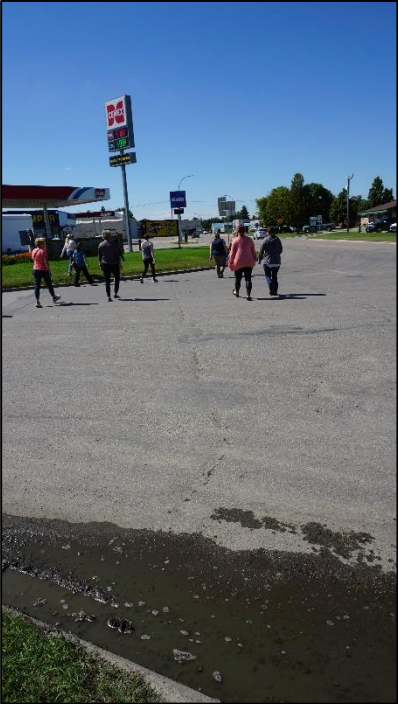
Due to the lack of crosswalk/sidewalk, the participants were observed scattered across the south side of ND Highway 5 while crossing ND Highway 1 as seen in Figure 14.

Figure 14. Lack of crosswalk/sidewalk on the south side of ND Highway 5 at ND Highway 1

As and when traffic volume grows, a needs assessment should be completed to determine if a traffic signal is warranted at the intersection of ND Highway 1 and ND Highway 5. Also, a needs assessment should be completed to determine if a midblock crosswalk is warranted along ND Highway 5, especially where such a crosswalk would connect high-pedestrian-demand locations such as where grocery shops are across the highway from residential areas.

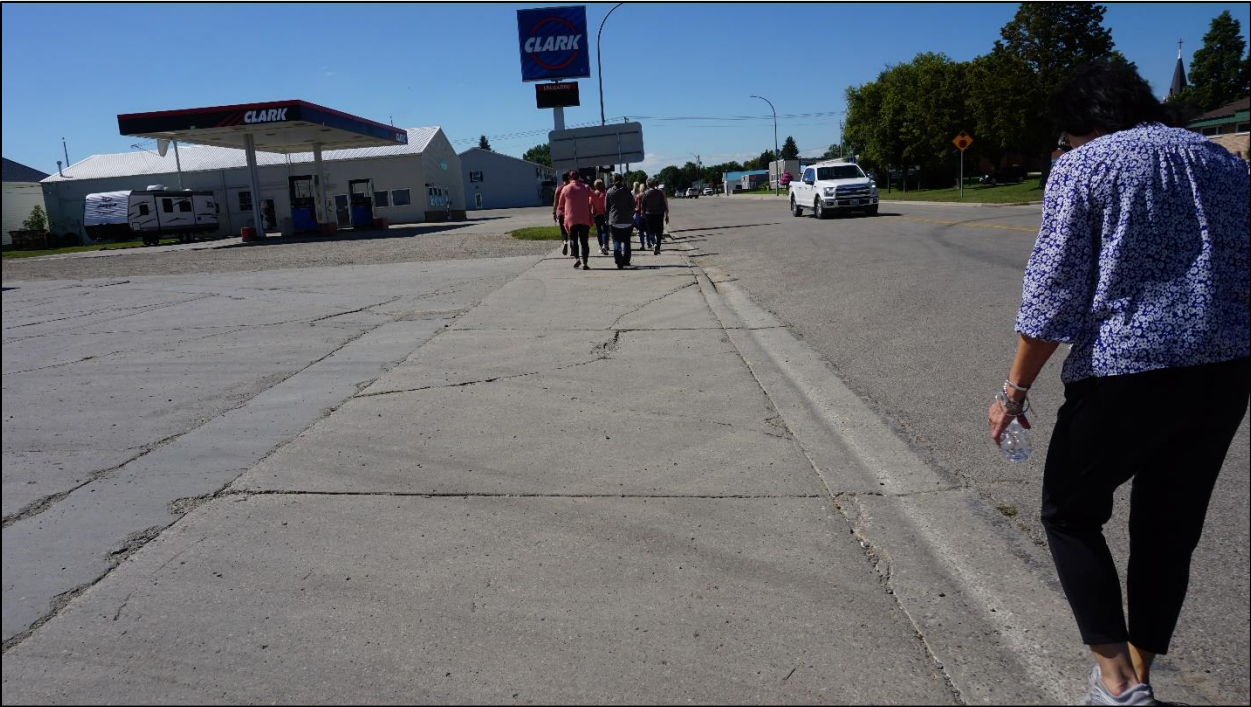
Figure 15. Sidewalk along the south side of ND Highway 5

As seen in Figure 15, in some locations along the south side of ND Highway 5, the differences among greenspace/furnishing zone, pedestrian zone, and frontage zone/parking lot were not apparent.

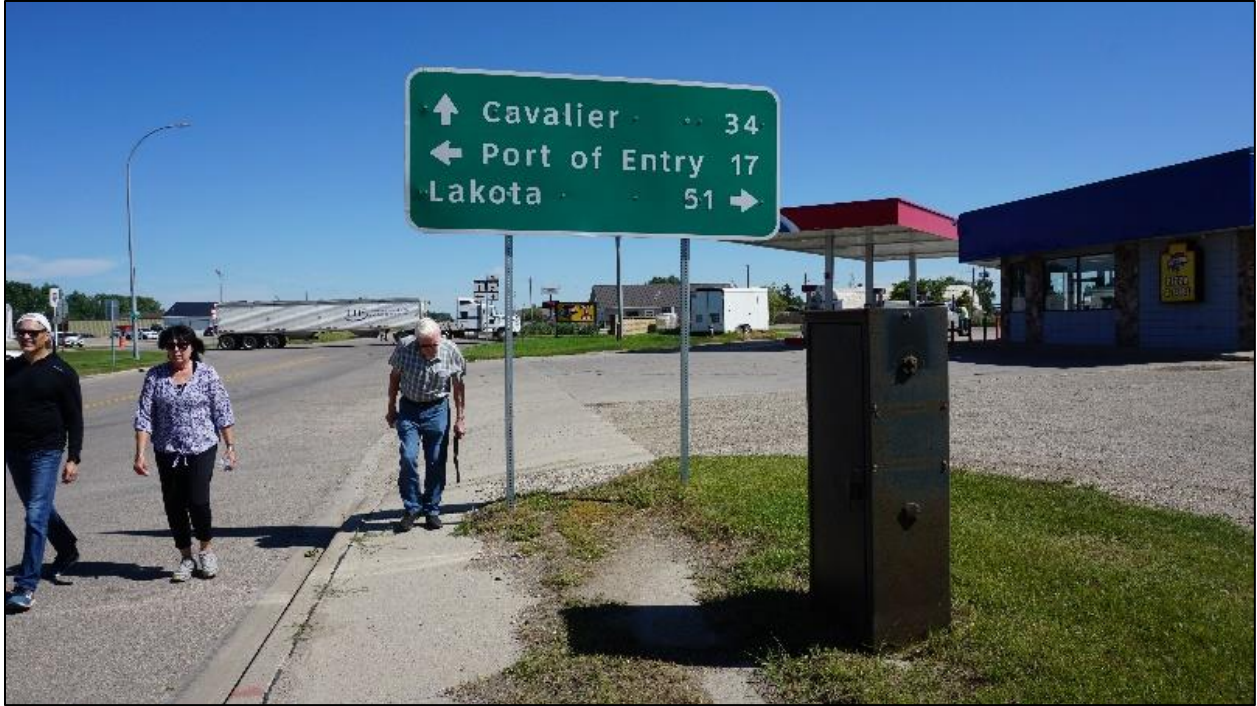
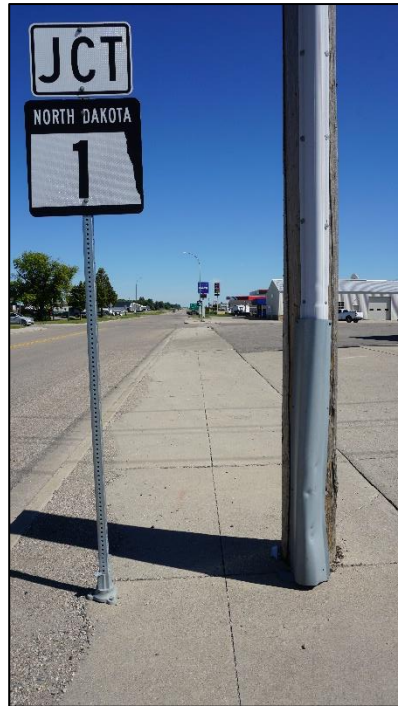
Figure 16. Guide sign obstructing the sidewalk

Figure 17. Route sign and utility pole obstructing sidewalk

In some locations along the south side of ND Highway 5, guide signs and utility poles were observed obstructing the sidewalk as seen in figures 16 and 17, forcing pedestrians off of the sidewalk and otherwise posing splinter- and creosote-related dangers.

Obstructive utility poles should be relocated to provide a clear pedestrian zone for non-motorized users. In this case close collaboration between transportation agencies and electric service providers would be paramount.

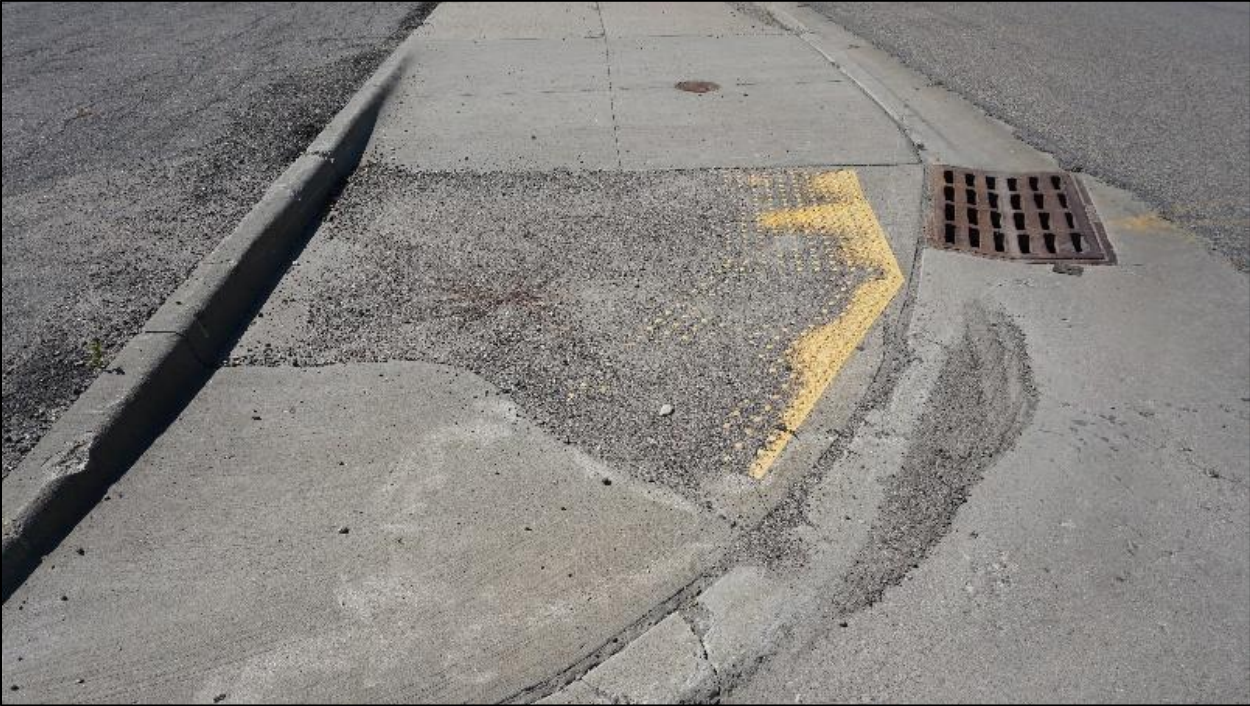
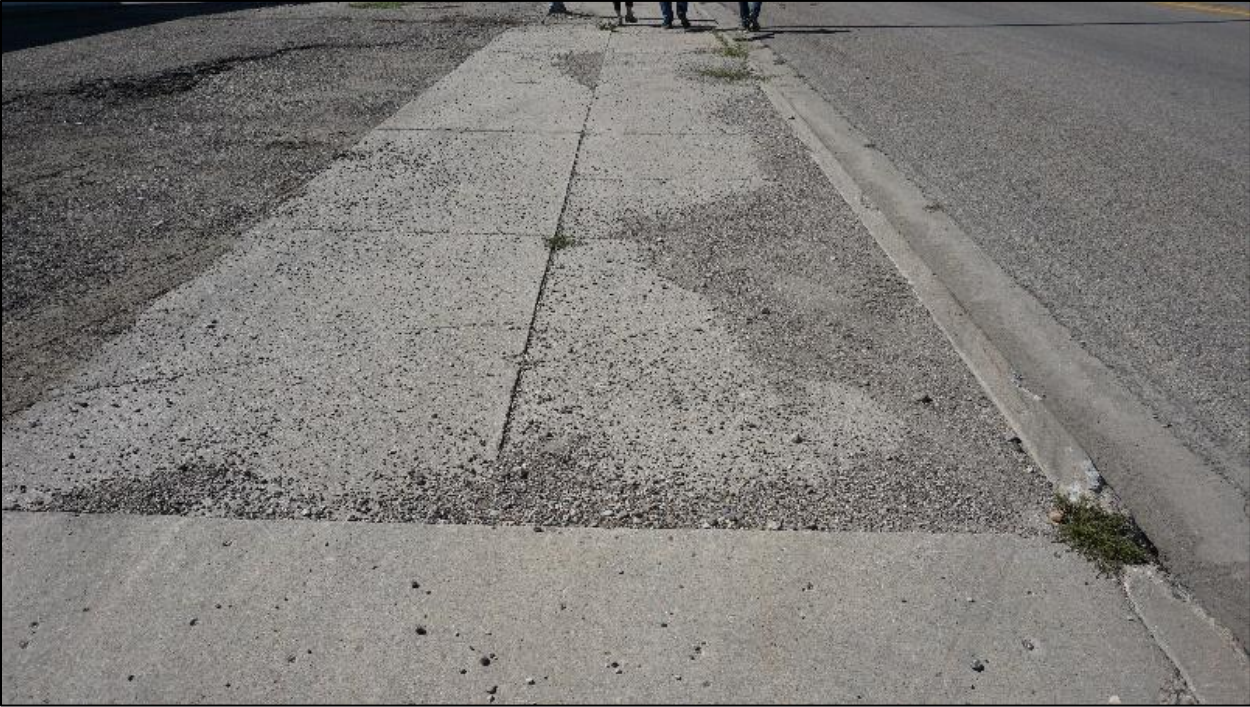
Figure 18. Debris strewn across ramp and potentially hazardous grate

Figure 19. Debris and weeds on the sidewalk

In some locations, truncated domes in curb ramps and the sidewalk were strewn with gravel, debris, and

weeds as seen in figures 18 and 19. Also, at the same location, an almost parallel storm water grate was observed.

Other nearby areas should also be assessed to ensure that grates for storm water drainage are such that they are not parallel to the direction of travel for bicyclists.

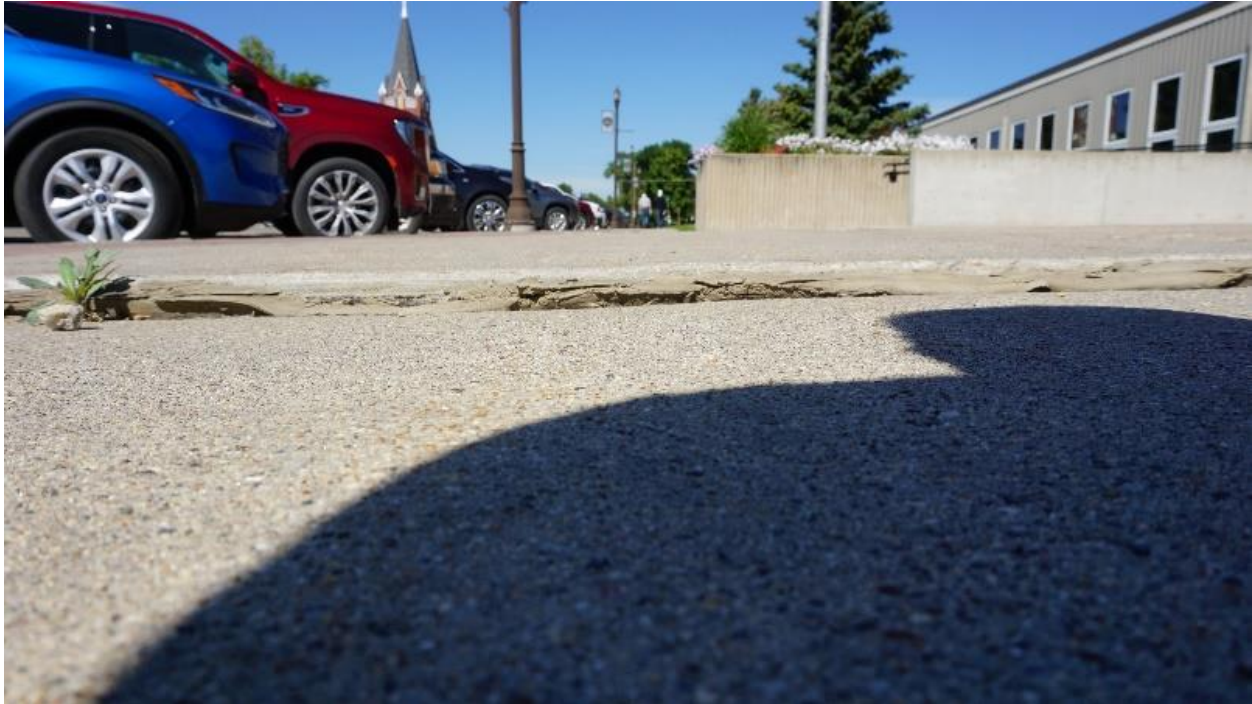
Along Third Street, sidewalk displacements, likely due to frost heaving, were observed presenting potential tripping hazards as shown in Figure 20.

Figure 20. Sidewalk displacement along Third Street

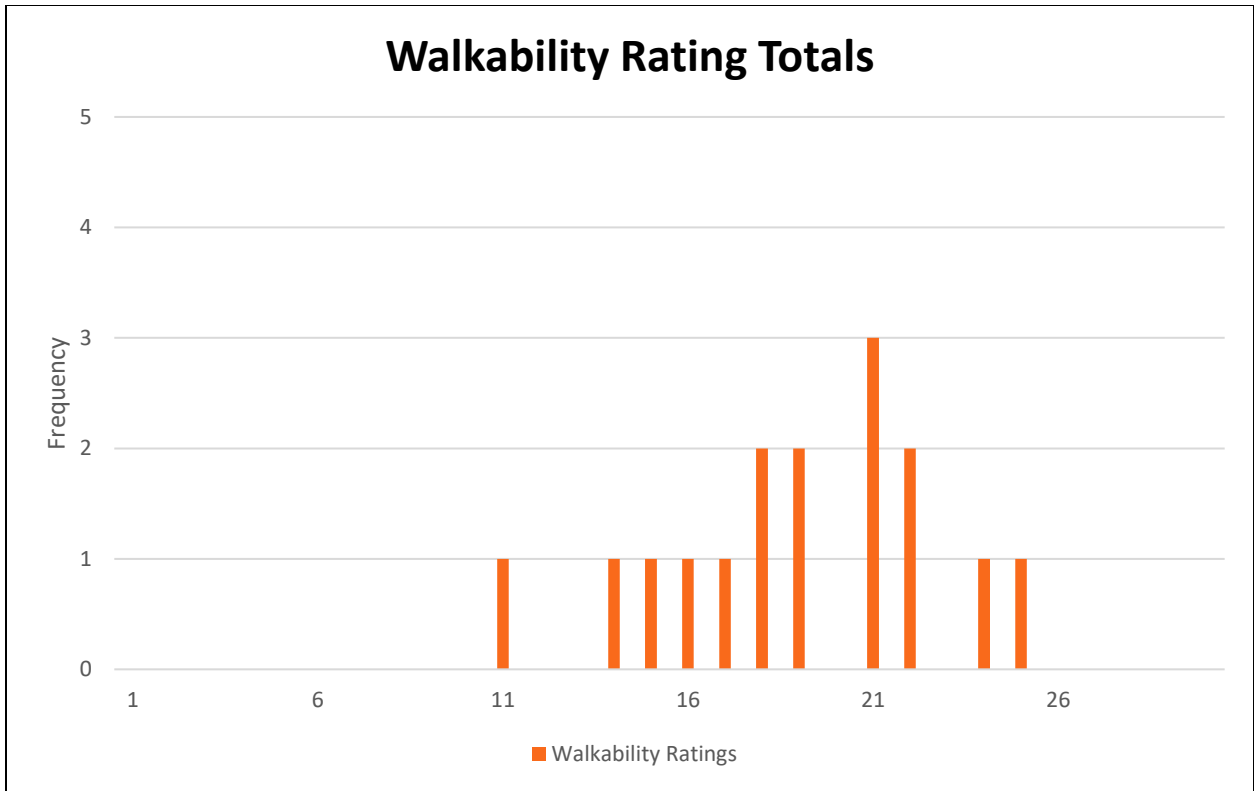
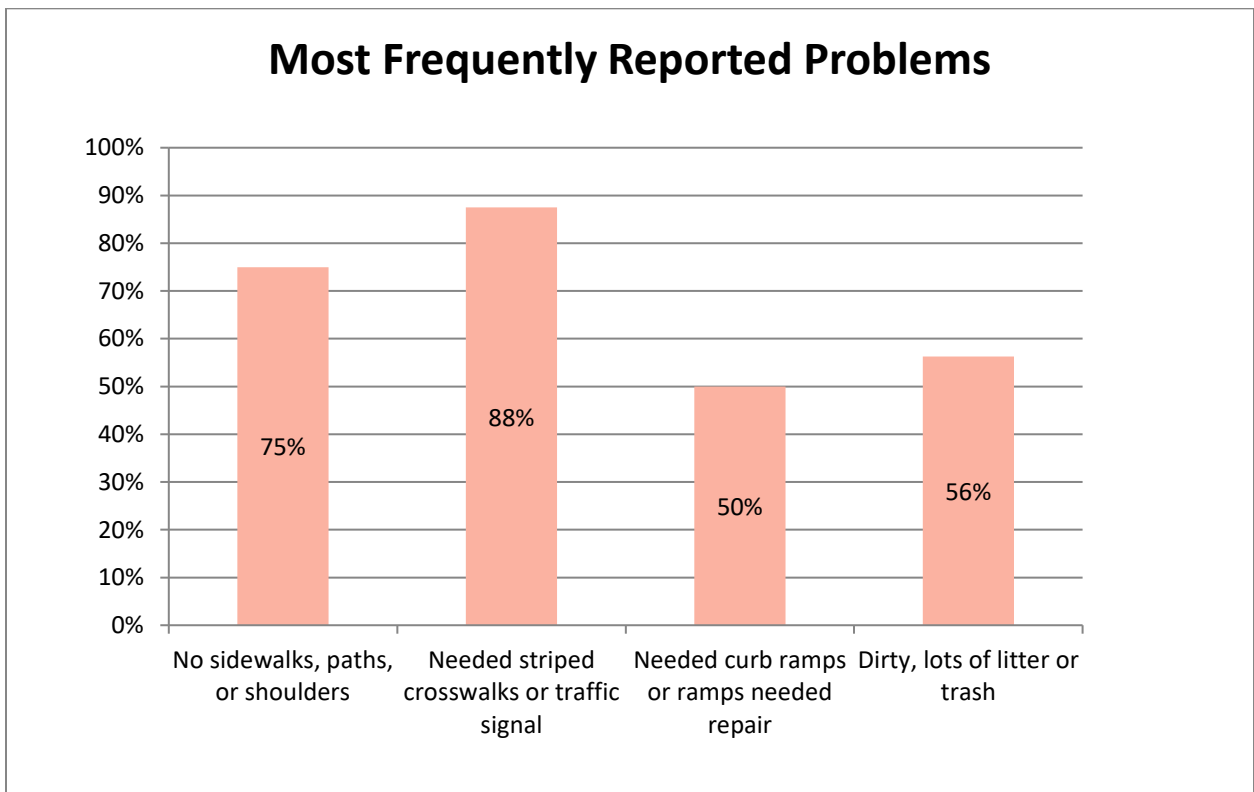
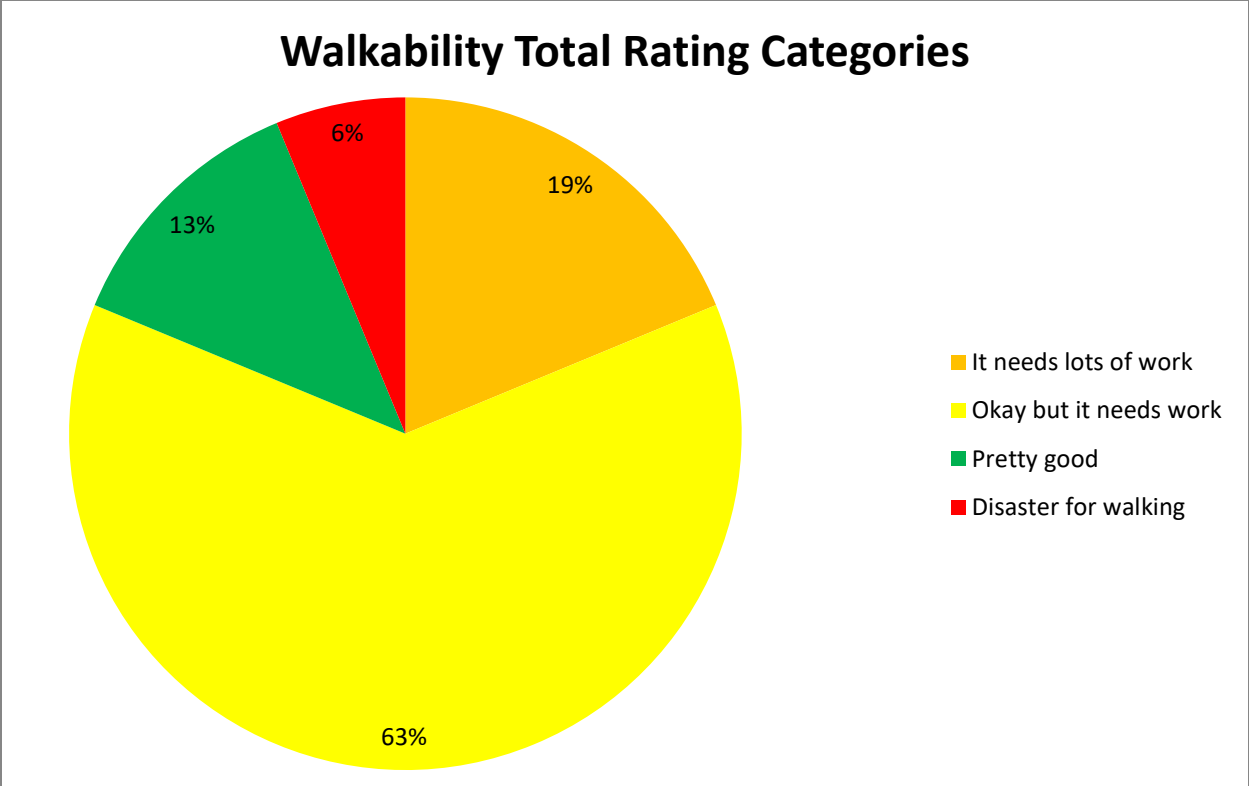
A total of 16 checklists were completed during this assessment. Based on the compiled results, participants rated their walk and the infrastructure at about an average of 21 as seen in Figure 21 below. As seen in Figure 22, the two most frequently reported problems were:

1. Needed striped crosswalk or traffic signal
2. No sidewalk, paths, or shoulder

These reports and other results highlight the lack of pedestrian-related infrastructure along most of the assessed loop. The assessment results also show that most of participants agree that the infrastructure is in need of work (see Figure 23).

Figure 21. Walkability ratings totals chart

Figure 22. Most frequently reported problems chart

Figure 23. Walkability total ratings categories chart
